#EPA-R6-2013-005422

NPDES Compliance Inspection Report

Supplemental Information for CAFO Facilities

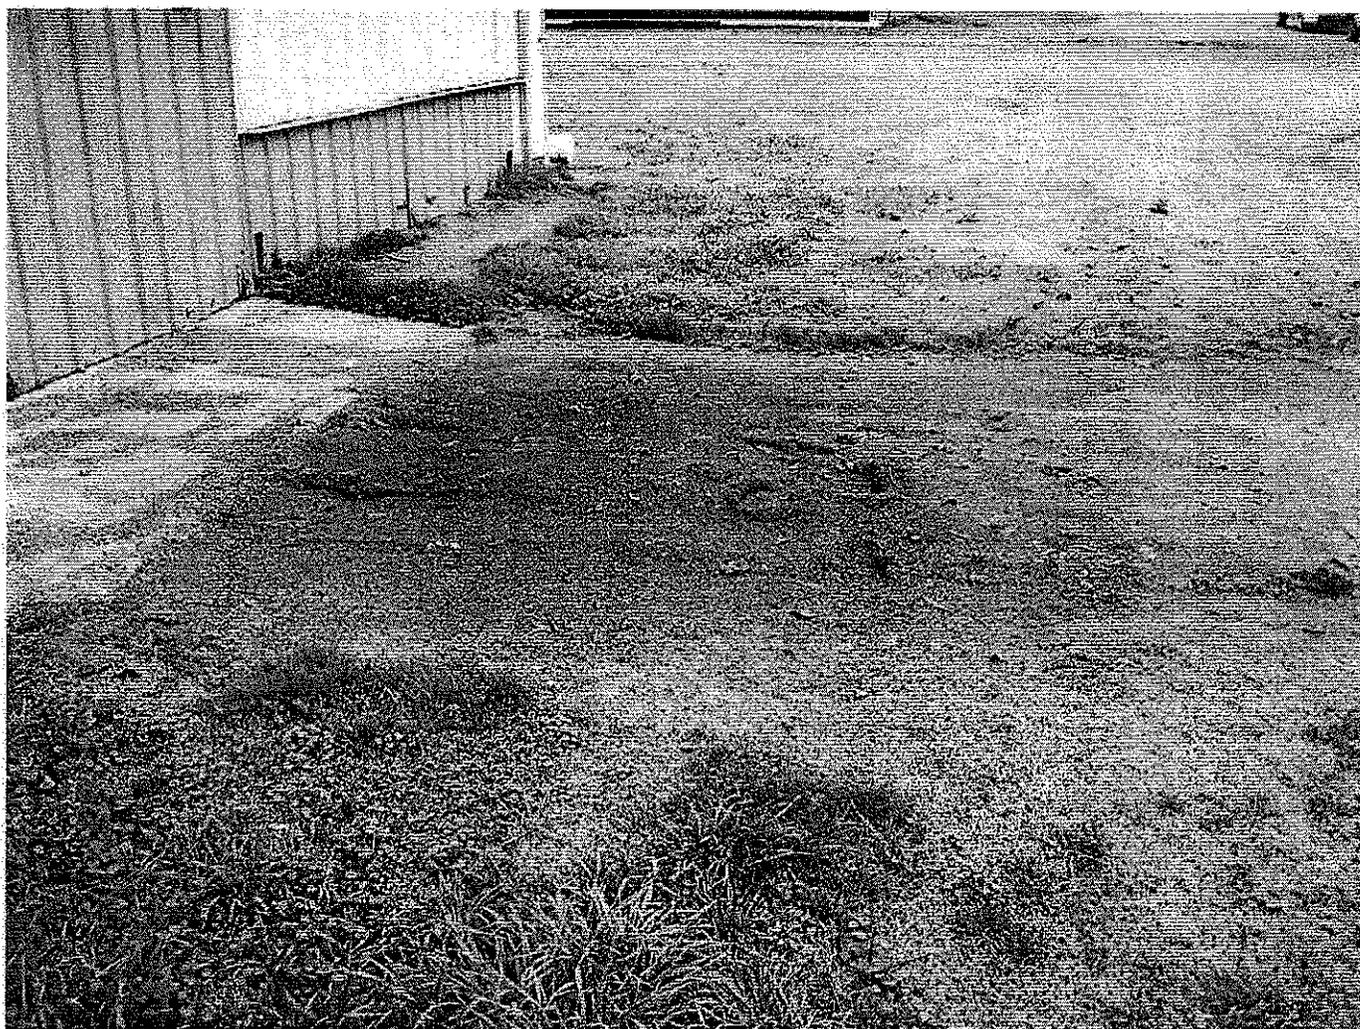
Photo # 2

Photographer: Juan Ibarra	Date: 8 January 2013	Time: 0959
City/County: [REDACTED]	State: [REDACTED]	
Location: [REDACTED]		
Subject: Litter spillage was found in front of the most southerly house. Need to shovel up the excess amounts of spilled litter when cleaning the barns or removing chickens.

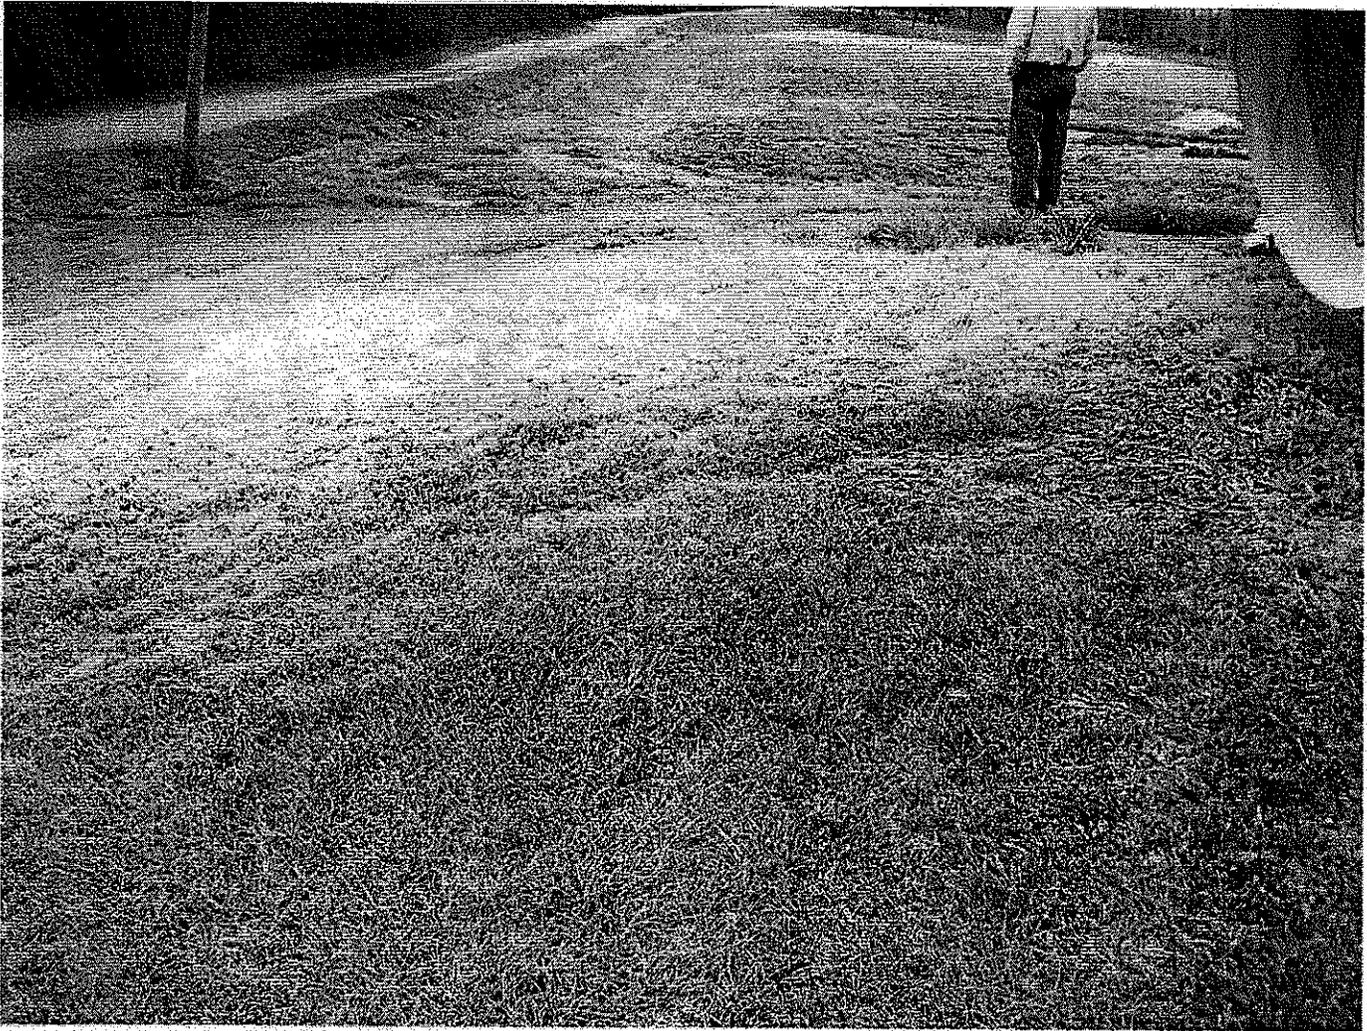
Photo # 3

Photographer: Juan Ibarra	Date: 8 January 2013	Time: 1004
City/County: [REDACTED]	State: [REDACTED]	
Location: [REDACTED]		
Subject: Feathers and poultry house dust have accumulated at the exhaust fans of the most southern house. Drainage would move down the drainage ditch shown on the left side of the road, and into the stock tank located about 300' beyond the poultry houses.

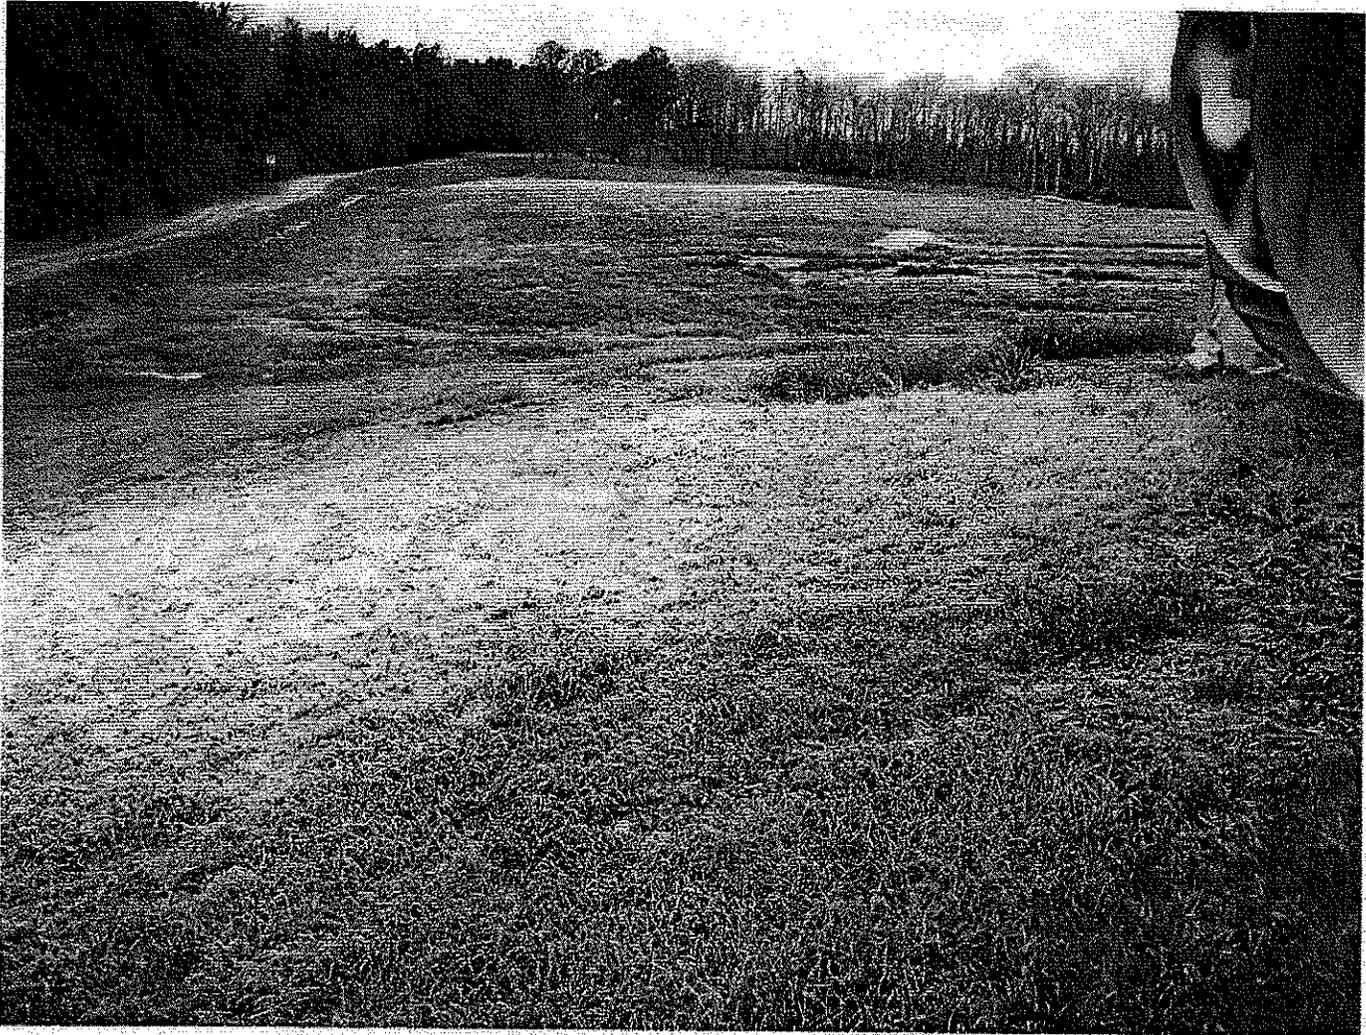
Photo # 4

Photographer: Juan Ibarra	Date: 8 January 2013	Time: 1004
City/County: [REDACTED]	State: [REDACTED]	
Location: [REDACTED]		
Subject: Feathers and poultry house dust have accumulated at the exhaust fans of the most southern house. Drainage would move down the drainage ditch shown on the left side of the road, and into the stock tank located about 300' beyond the poultry houses. The stock tank is in the distant background.

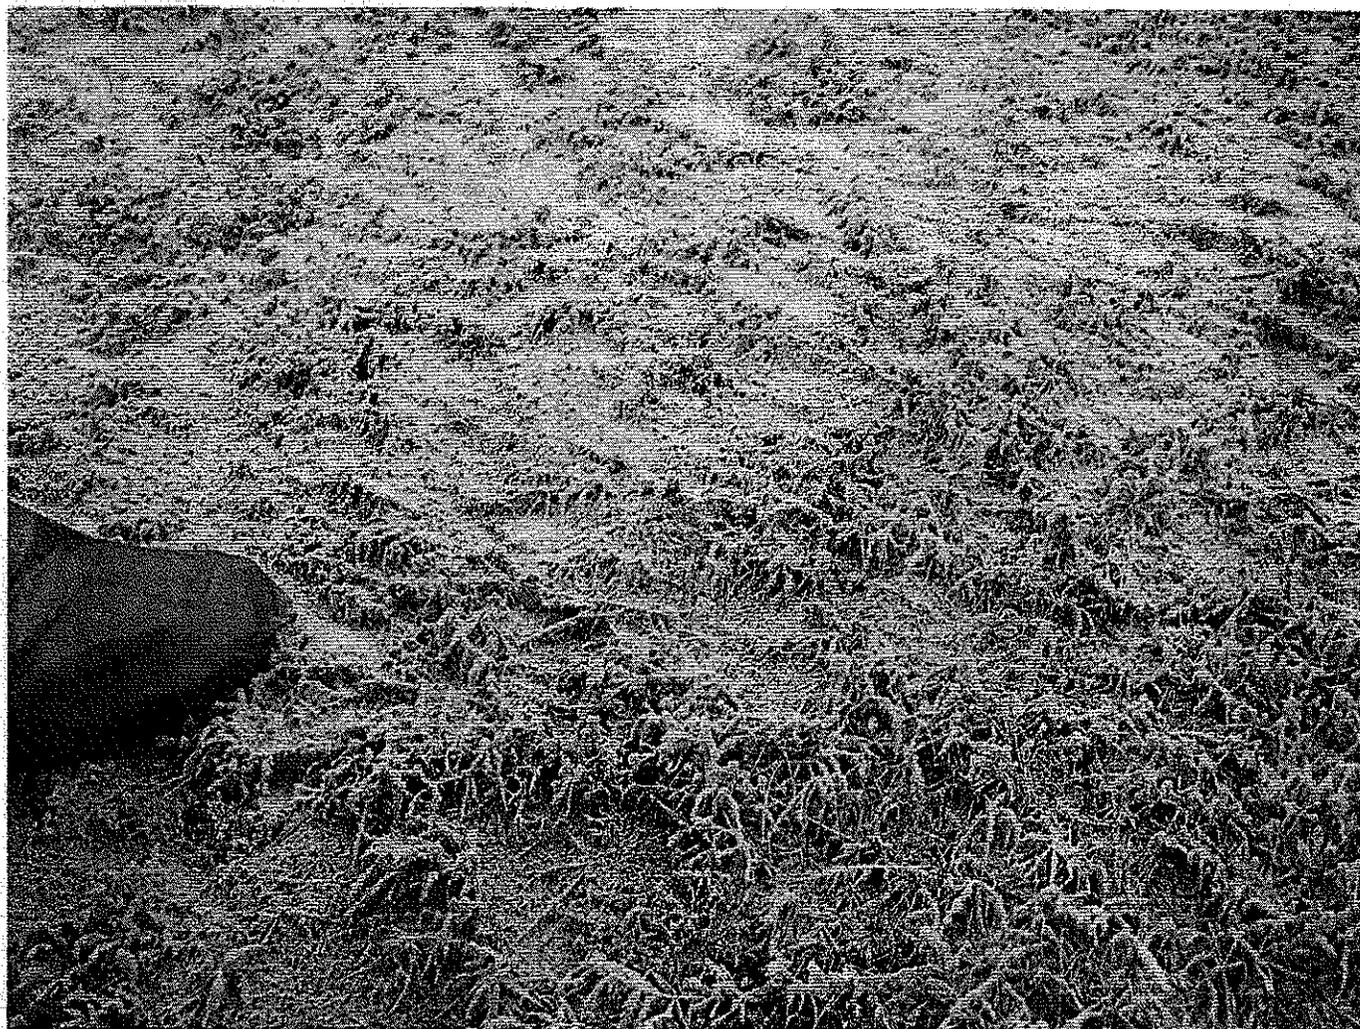
Photo # 5

Photographer: Juan Ibarra	Date: 8 January 2013	Time: 1006
City/County: [REDACTED]	State: [REDACTED]	
Location: [REDACTED]		
Subject: Close-up of the feathers and poultry house dust that have accumulated on the ground, outside of the exhaust fans of the most southern house.

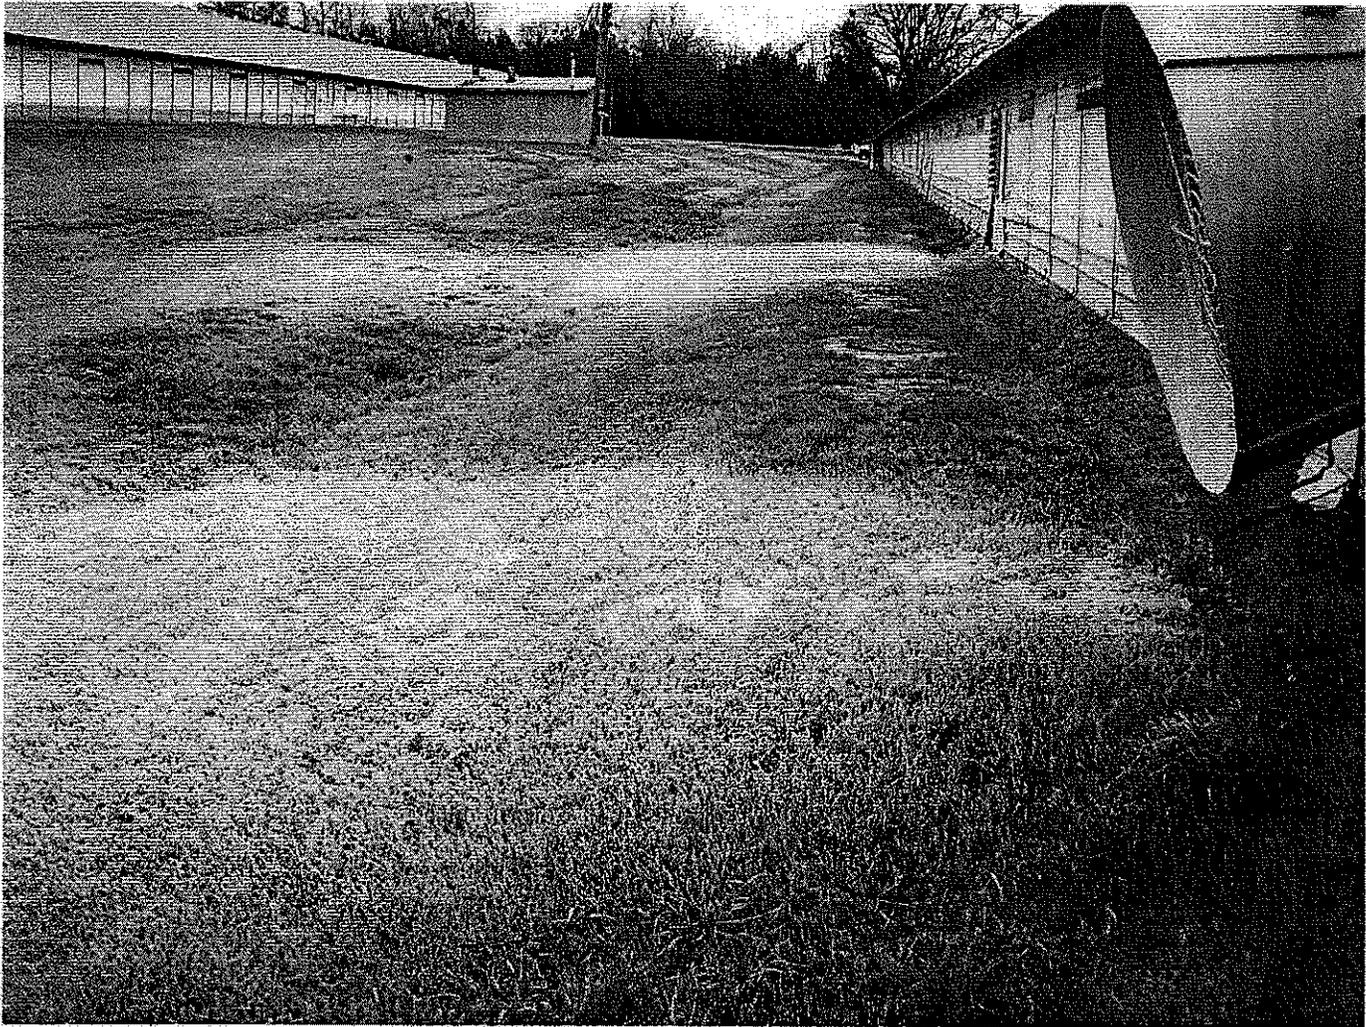
Photo # 6

Photographer: Juan Ibarra	Date: 8 January 2013	Time: 1013
City/County: [REDACTED]n	State: [REDACTED]	
Location: [REDACTED]		
Subject: Exhaust fan feathers and dust, as seen at the second house (next to the most southern house). The view is looking east.

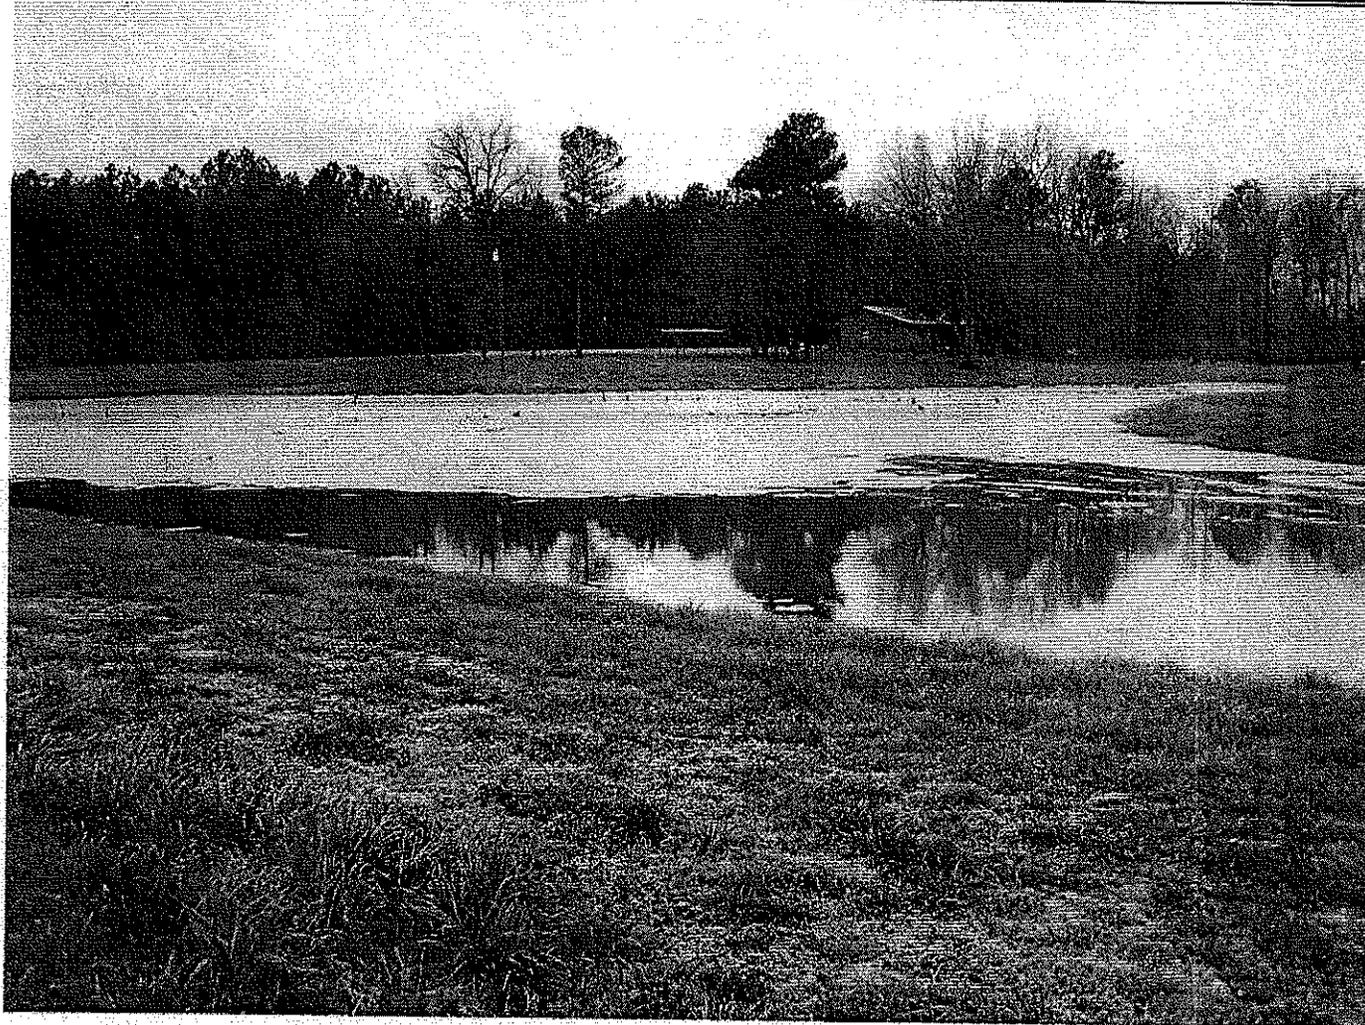
Photo # 8

Photographer: Juan Ibarra	Date: 8 January 2013	Time: 1030
City/County: [REDACTED]	State: [REDACTED]	
Location: [REDACTED]		
<p>Subject: The stock tank has a lot of duck weed growing on the surface. This tank could be affected by the application of chicken litter, by the tenant that leases the property, within 20' of the stock tank. A greater buffer of close to 100' was recommended due to the sloping grade of the pasture in this area, but at a minimum, 35' is a standard vegetated buffer from water bodies. A deer camp is in the background.</p>

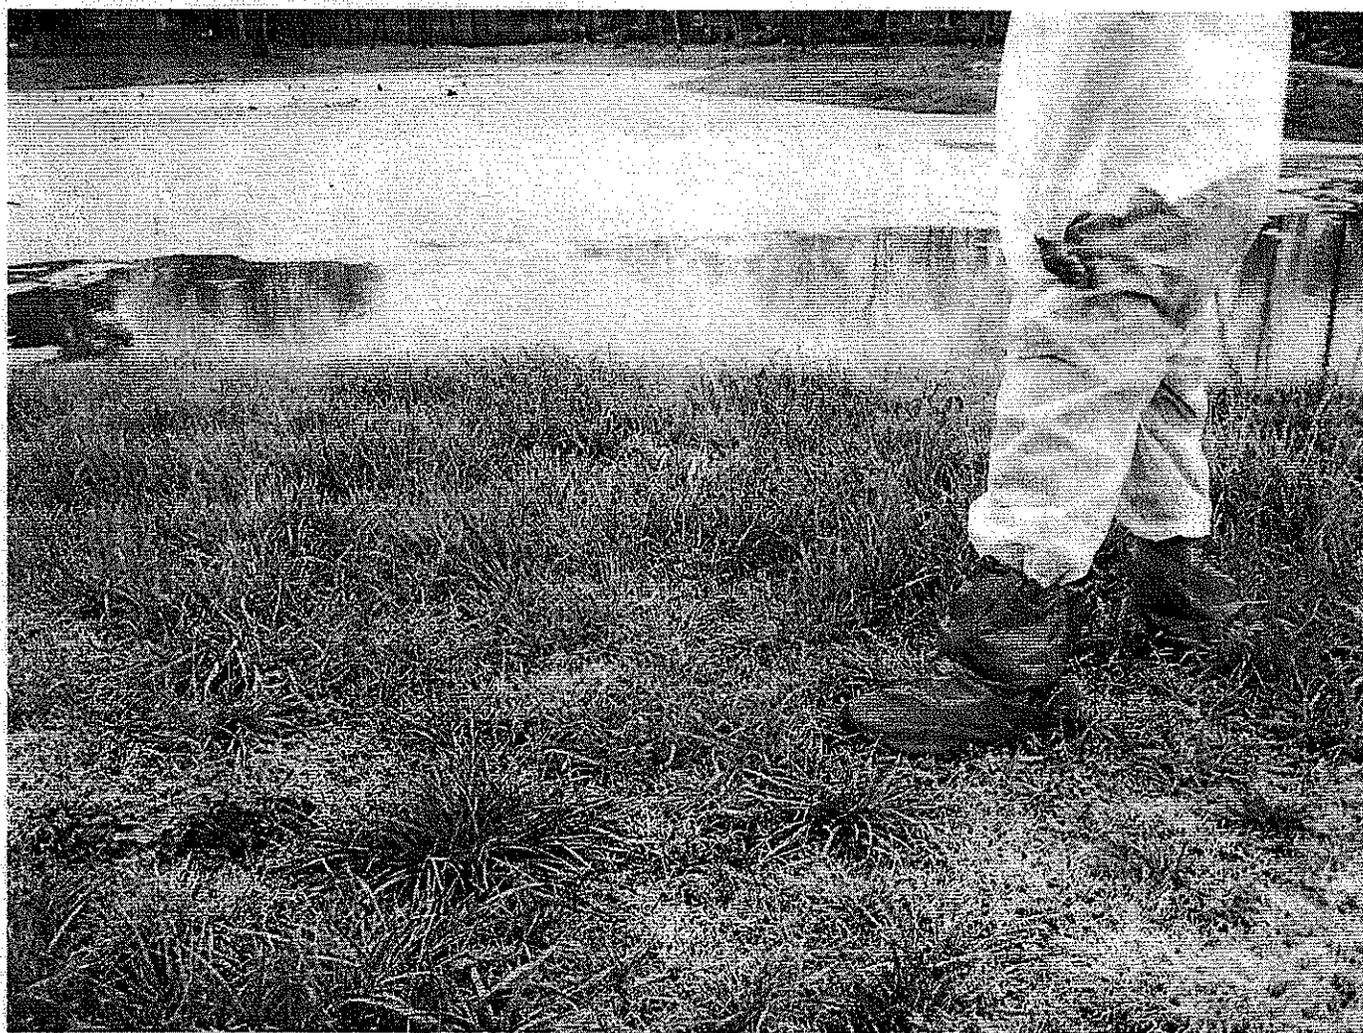
Photo # 9

Photographer: Juan Ibarra	Date: 8 January 2013	Time: 1032
City/County: [REDACTED]	State: [REDACTED]	
Location: [REDACTED]		
Subject: View of the land applied litter, within about 20' of the stock tank.

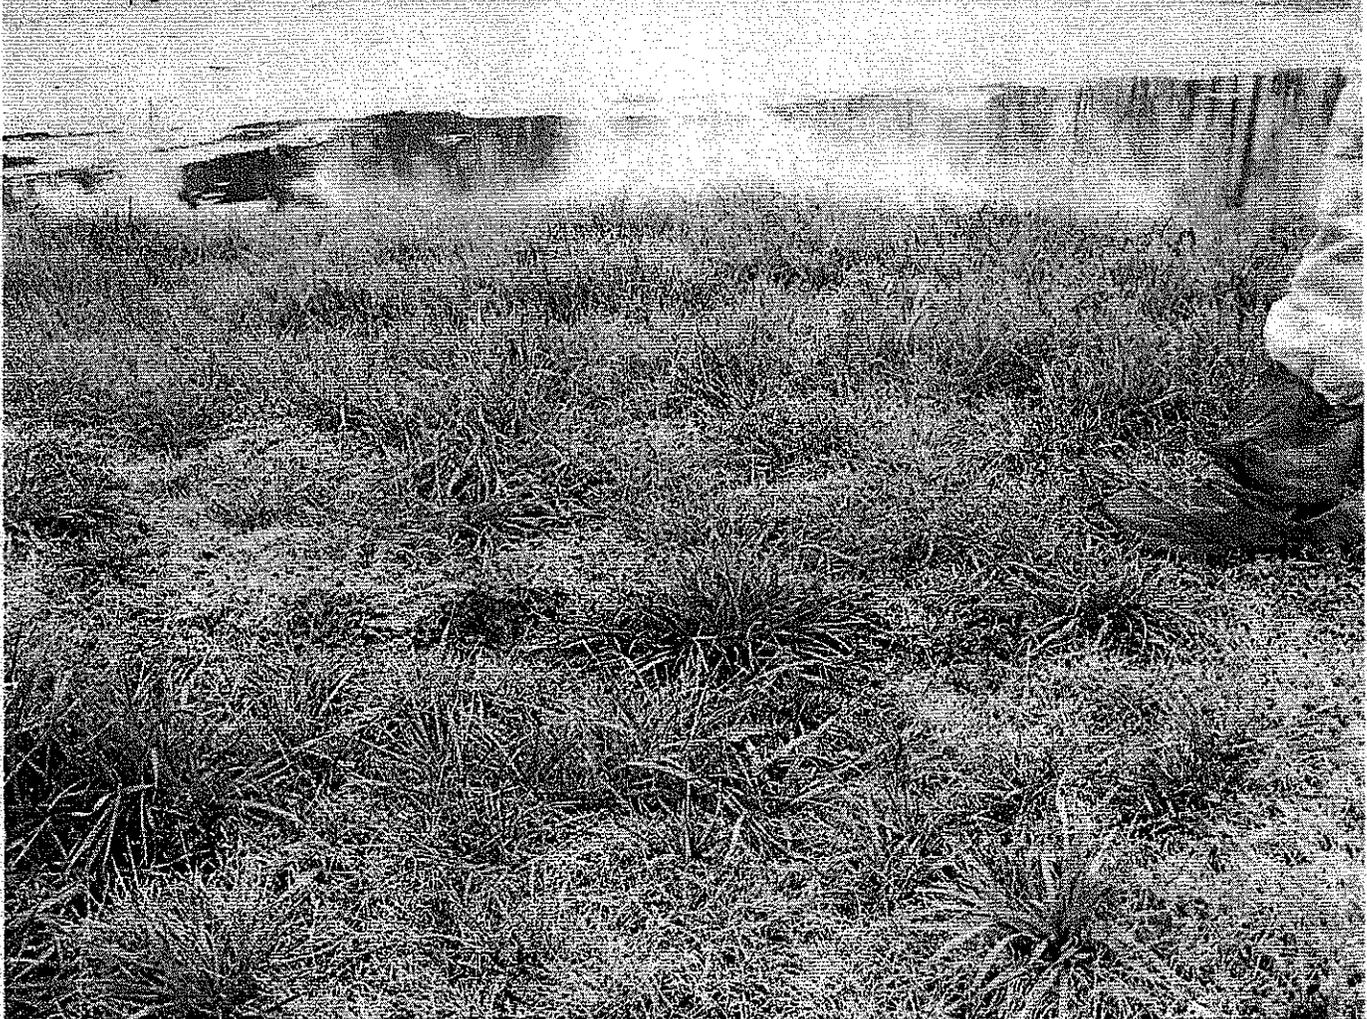
Photo # 10

Photographer: Juan Ibarra	Date: 8 January 2013	Time: 1033
City/County: [REDACTED]	State: [REDACTED]	
Location: [REDACTED]		
<p>Subject: A close-up view of the land applied litter, within about 20' of the stock tank. It appears that this application, which is too close to the stock tank, may be contributing to the water quality impairment of the stock tank. <u>A buffer closer to 100', but no less than 35'</u> should help reduce the impact of land applied nutrients on the stock tank, considering the slope that exists above the stock tank.</p>

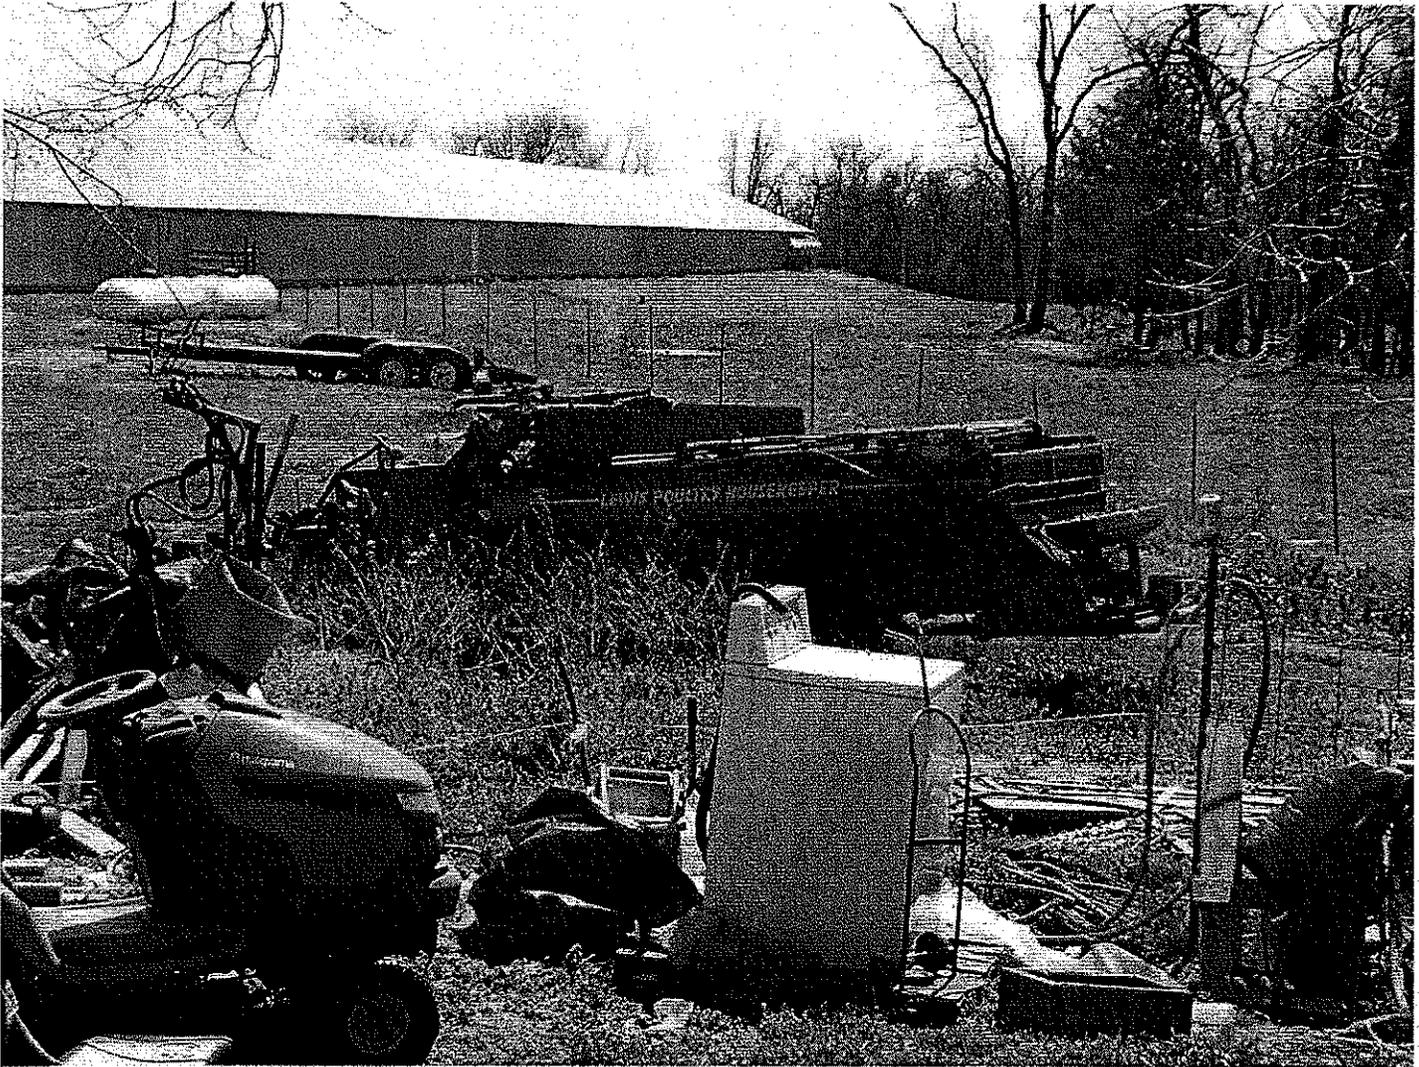
3

The "Poultry Housekeeper" which is used to sift the chicken litter in the houses, and for land application. The spreader attachment is on the back side of the unit.

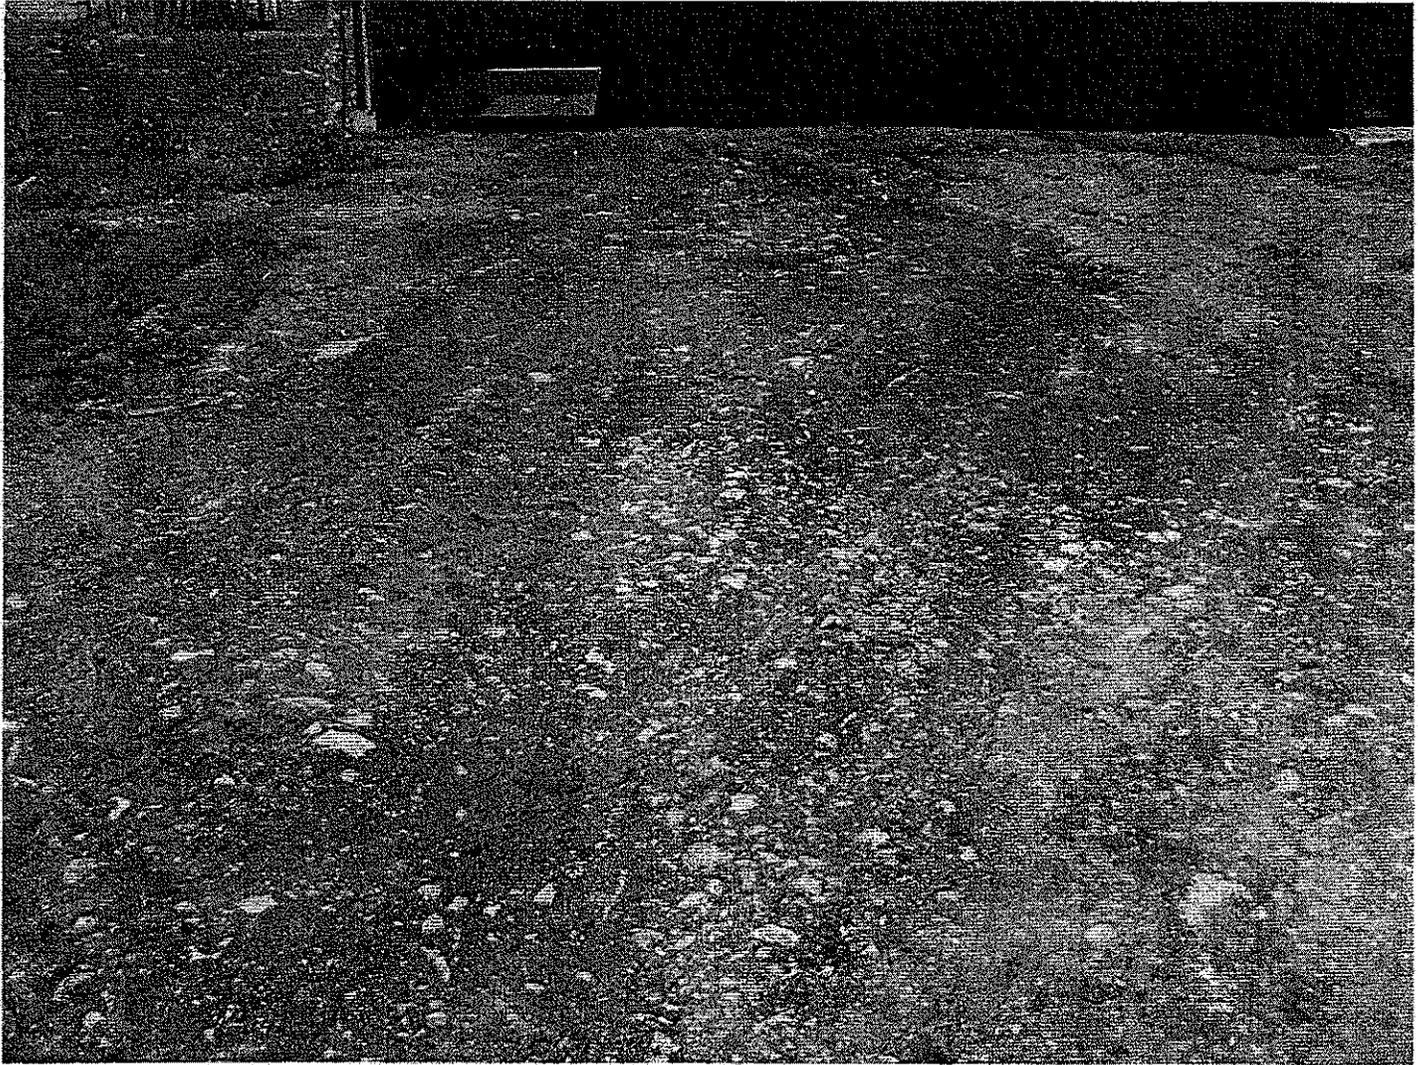
6

Litter has been tracked out of the shed. Rice hulls are also visible.

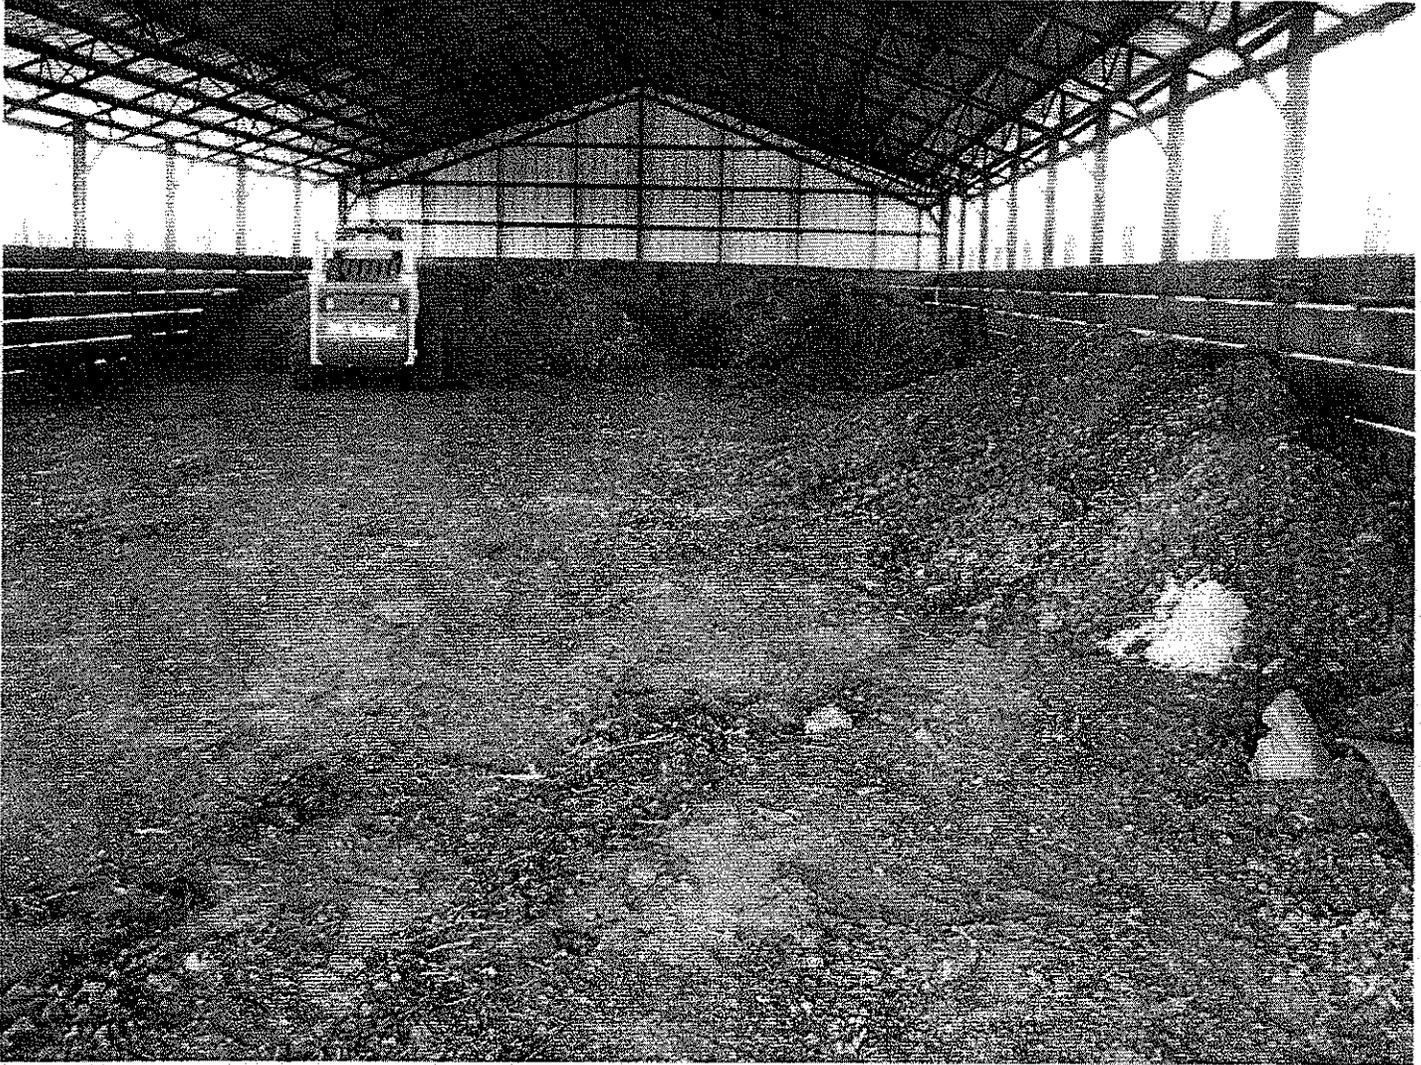
Picture Number:
8

The manure shed. The owner reported that he began to empty the shed in March, and will finish within a week.

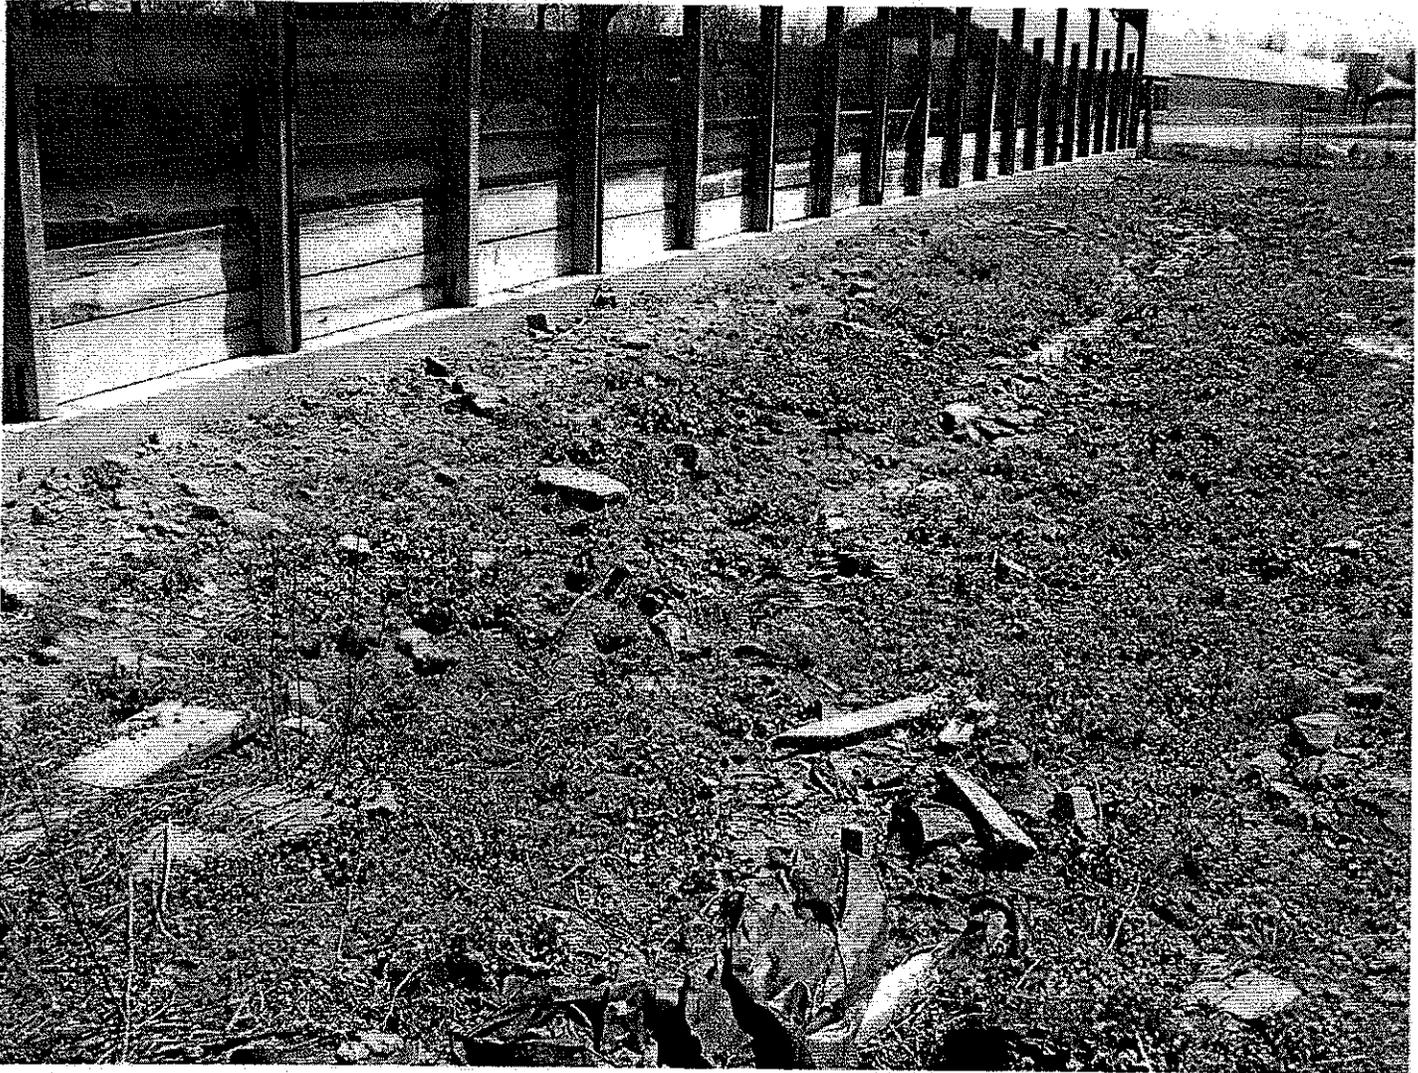
9

The area outside of the manure shed. The area is wet, but no visible manure solids were seen.

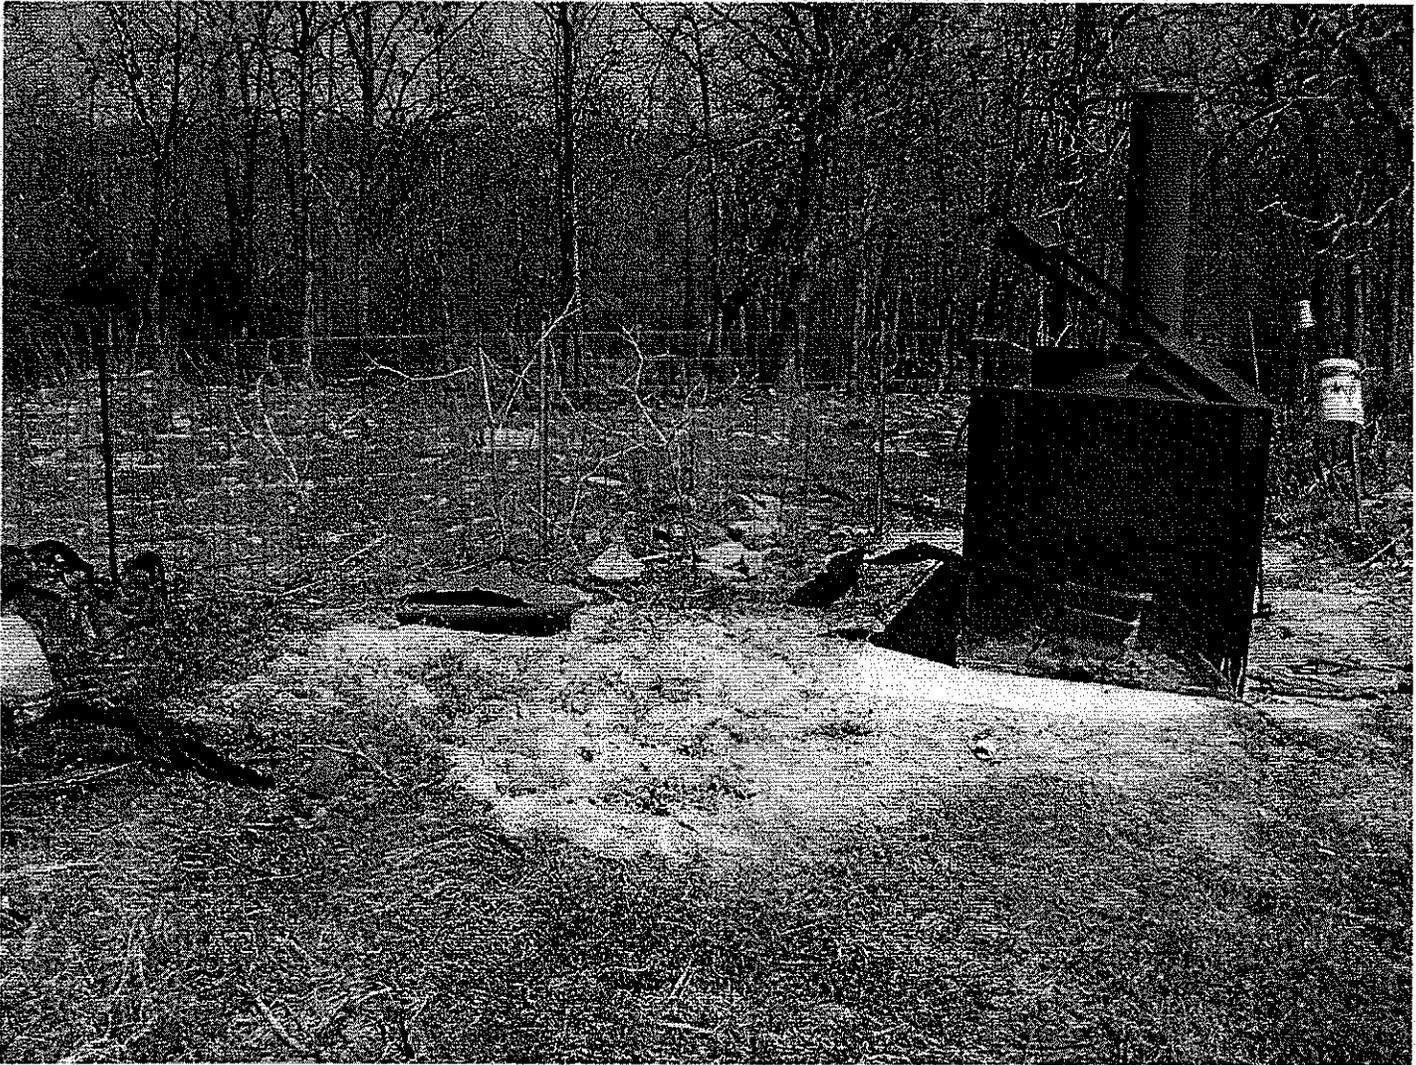
A close-up of the ash piled on the ground.

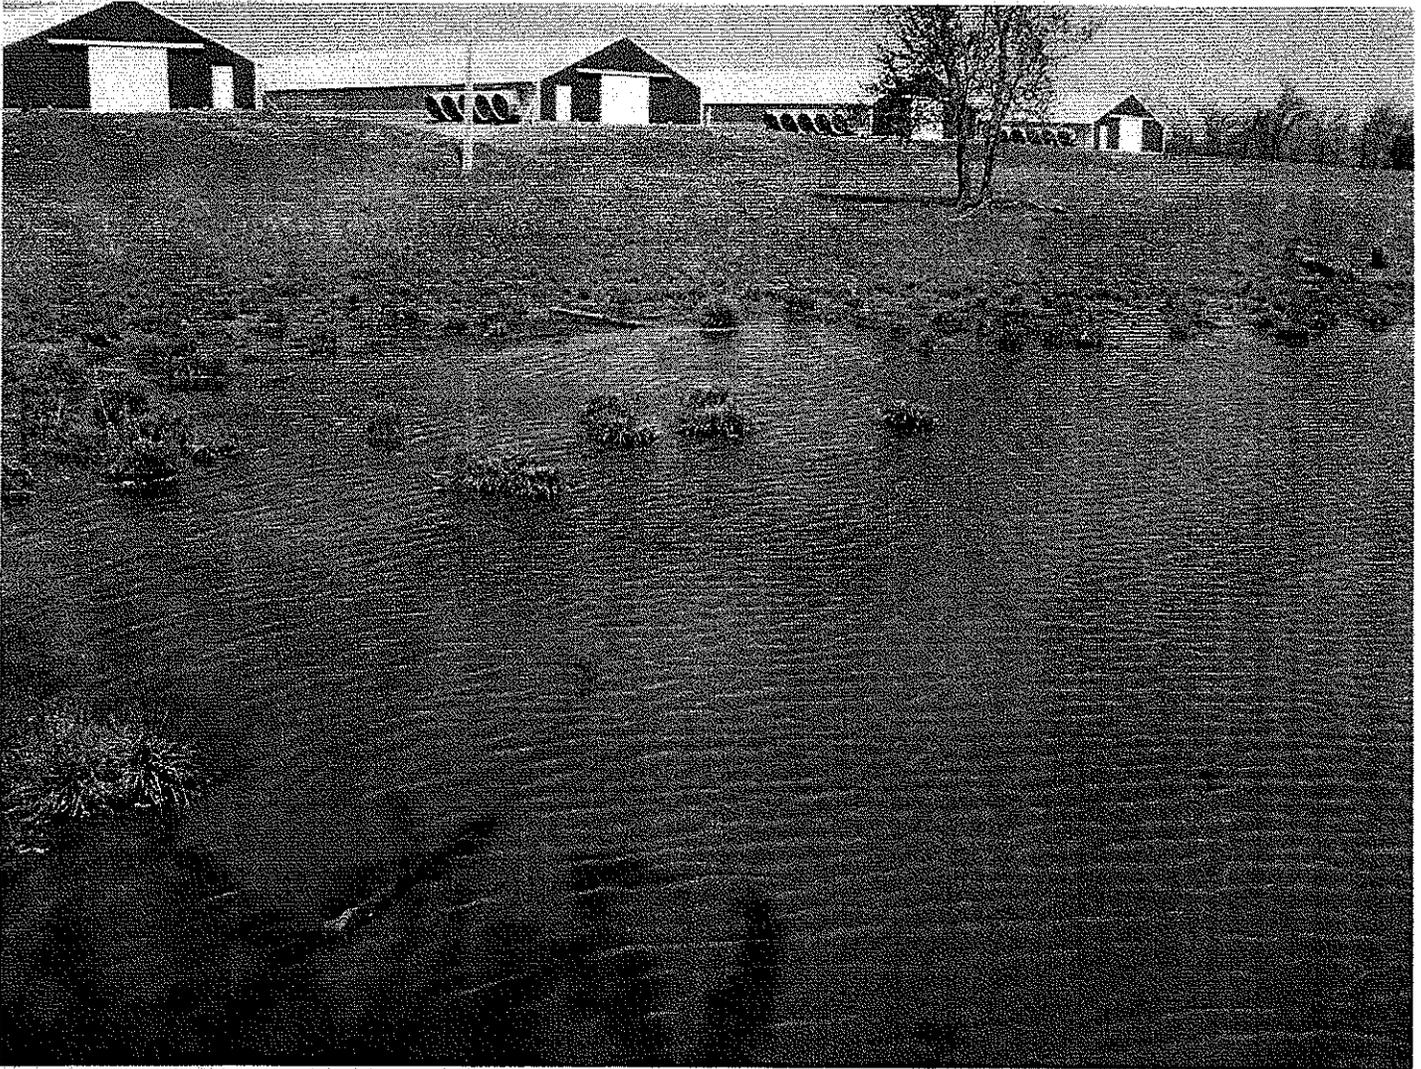
17

A stock tank on the south side of House 5. The pond is about 175' from the Chicken House, and did not appear to have excessive algal growth. The view is to the northeast.
